Property Inspection Report

12345 Any Street
Hometown, IL. 00000

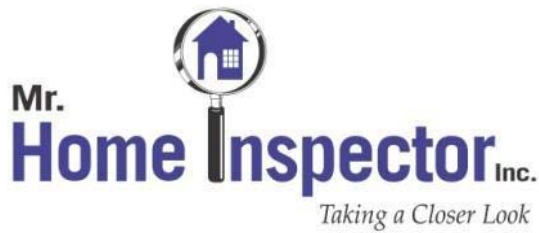
Mr. Home Inspector, Inc.

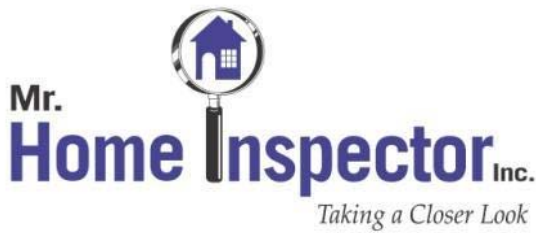
Mr. Home Inspector, Inc.

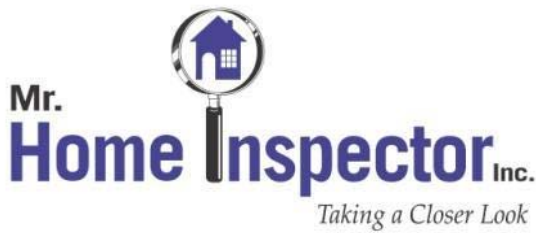
Mr. Home Inspector, Inc.

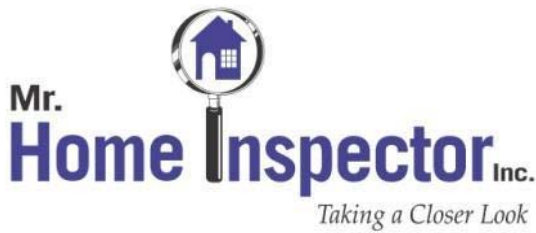
Mr. Home Inspector, Inc.

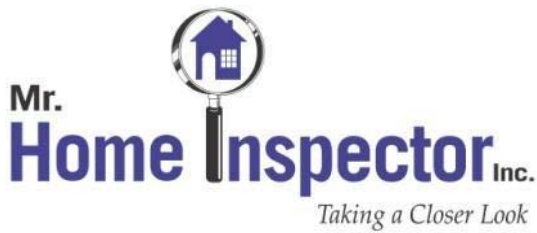
Mr. Home Inspector, Inc.

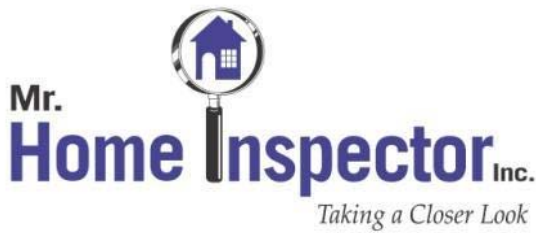
Mr. Home Inspector, Inc.

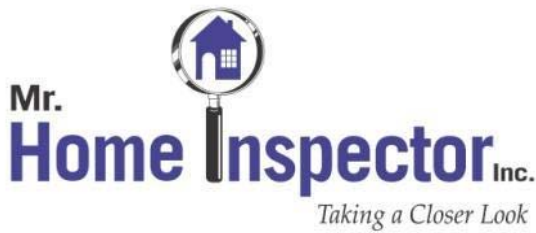
Mr. Home Inspector, Inc.

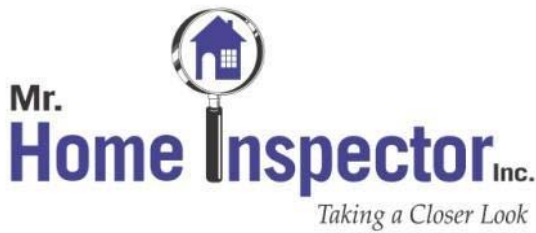
Mr. Home Inspector, Inc.

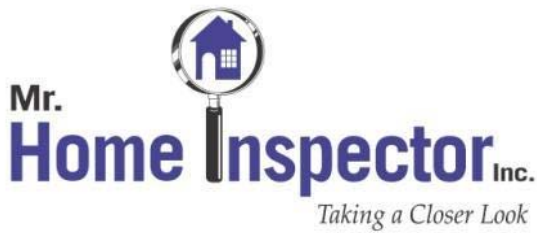
Mr. Home Inspector, Inc.

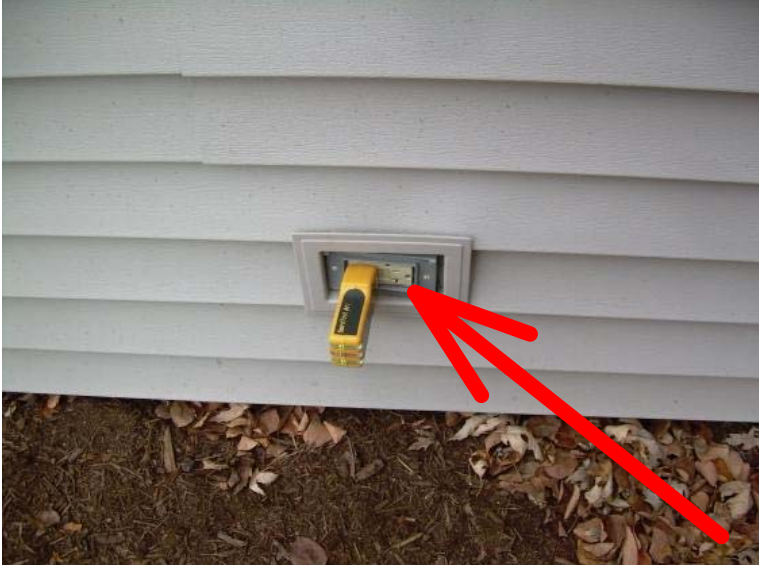
The GFCI outlet at the side of the garage is loose from the wall and is missing a weatherproof cover. Recommend repair or replacement of the outlet by a license electrician.

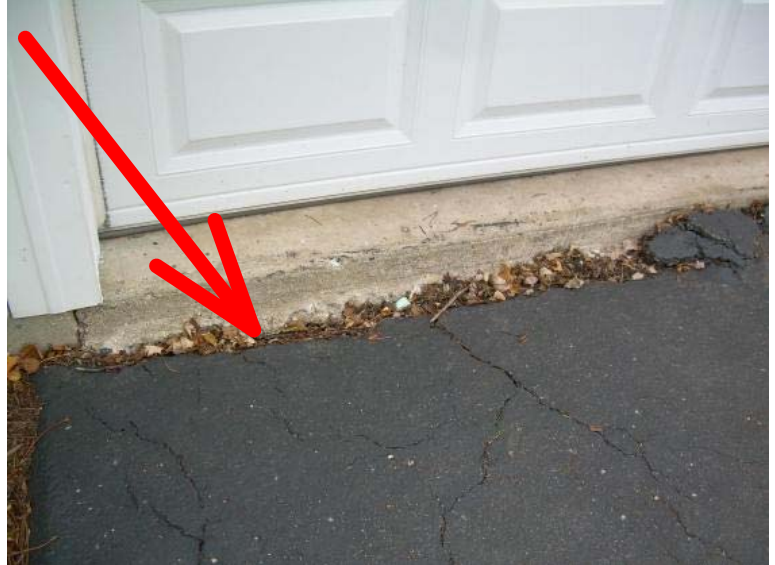
The driveway has settlement near the garage door with signs of previous repairs. Recommend repair or replacement of the driveway.

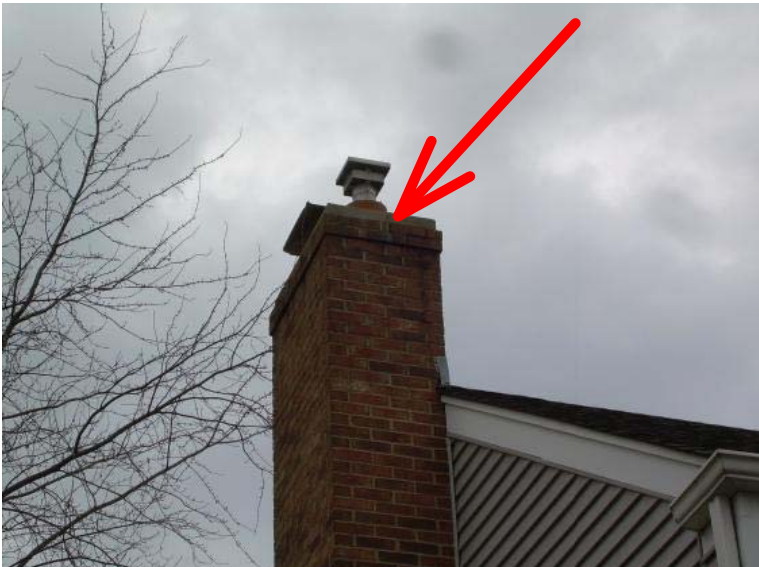
The chimney cap is cracked and in need of repair to help prevent moisture penetration.

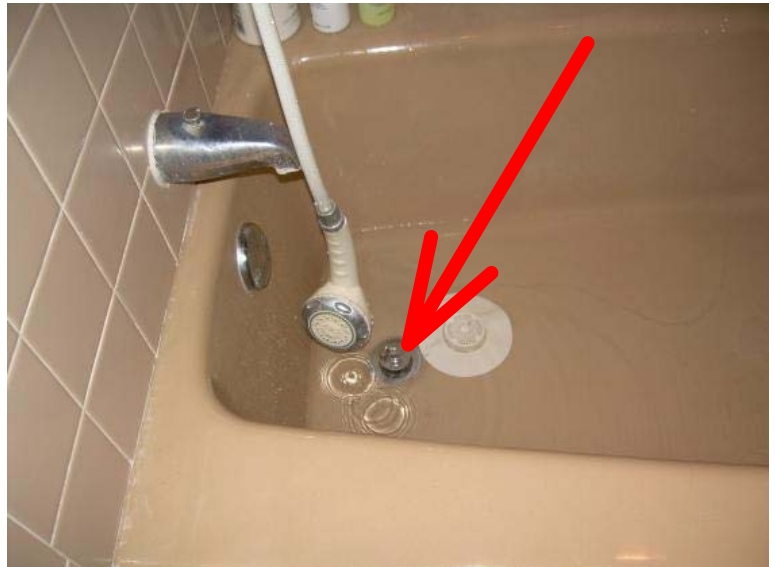
The master bath tub drains very slowly. Recommend cleaning of the drain.

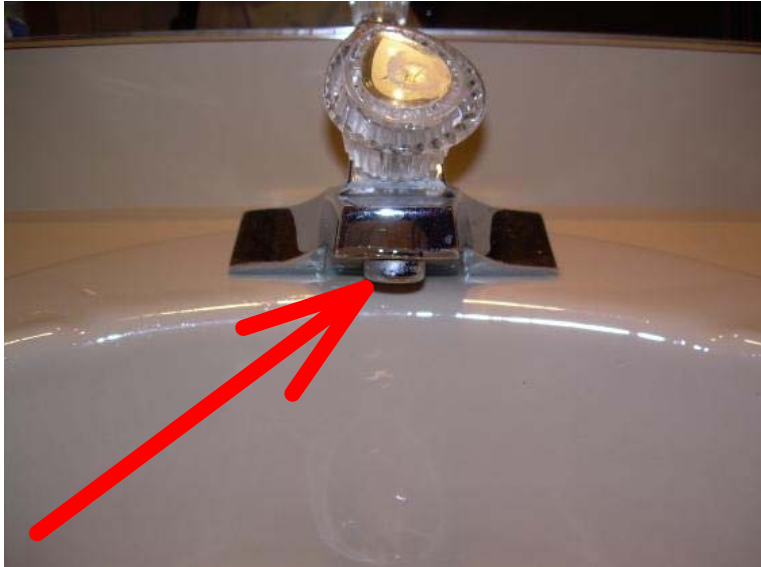
The left faucet in the upper hall bathroom has a leaking filter screen and is partially clogged. Recommend replacement of the filter screen.

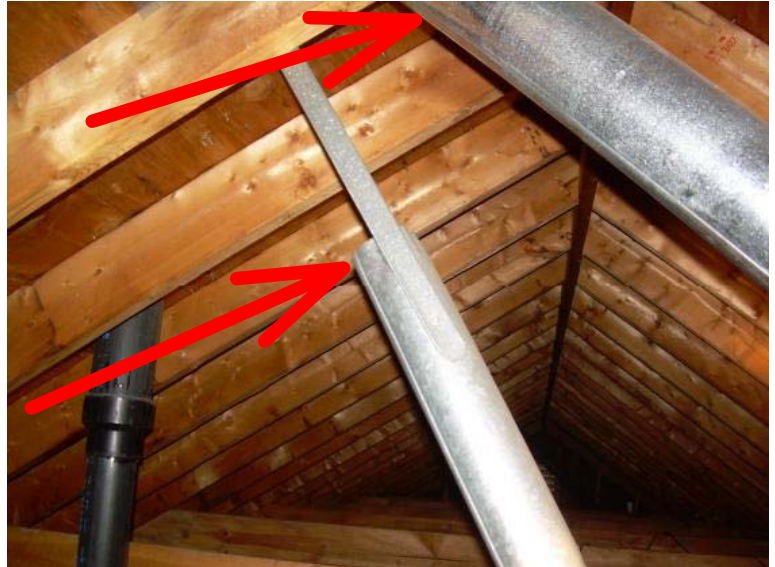
The bathroom vent fans improperly terminate inside the attic area and could cause excessive moisture to build up inside the attic. Recommend having a qualified contractor extend vents to the exterior of the home.

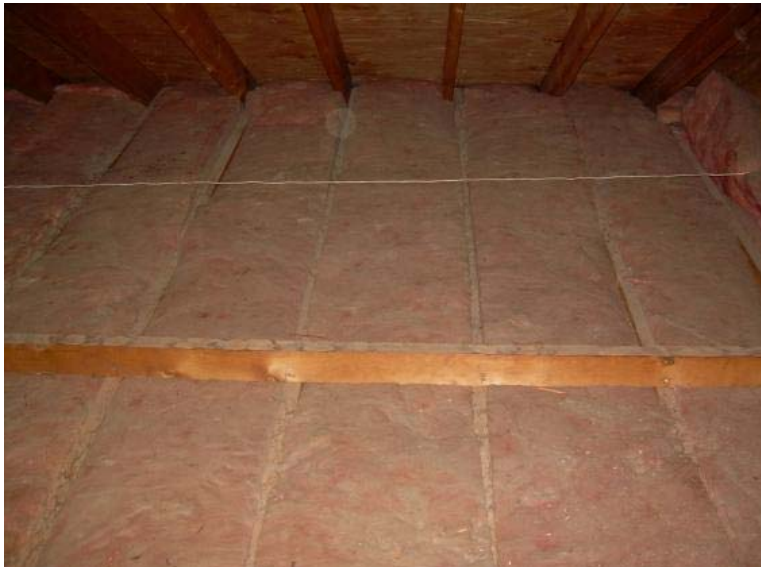
Recommend additional insulation be added to the main attic for better efficiency. There is only 6 inches of insulation present.

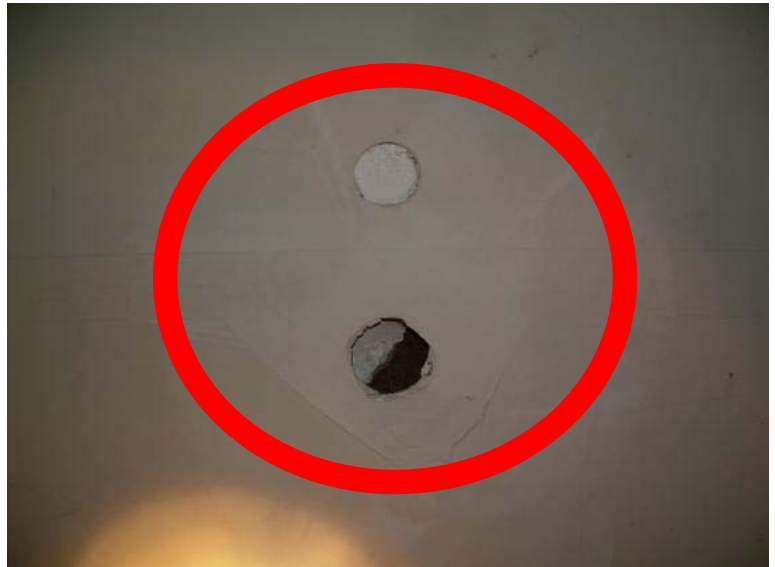
There are several holes in the walls of the garage. Recommend repairs be made to prevent breach of firewall protection.

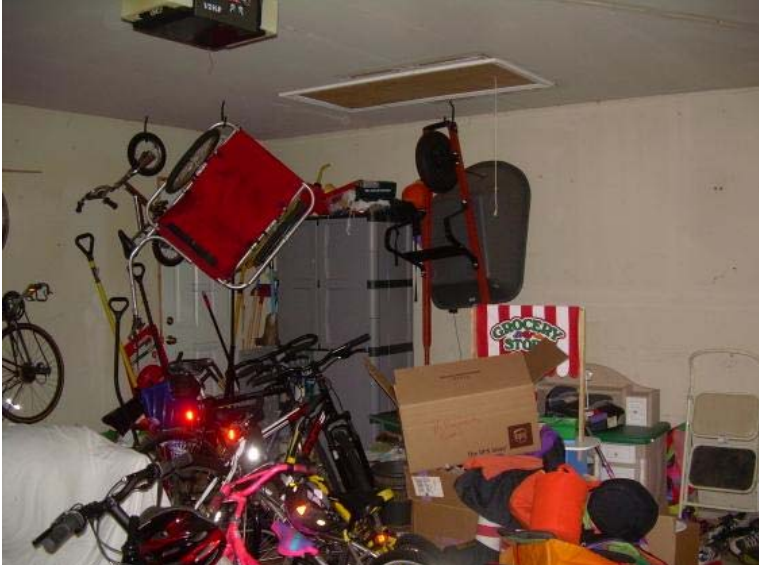
The garage attic could not be inspected because of personal belongings stored in the garage under the attic opening.

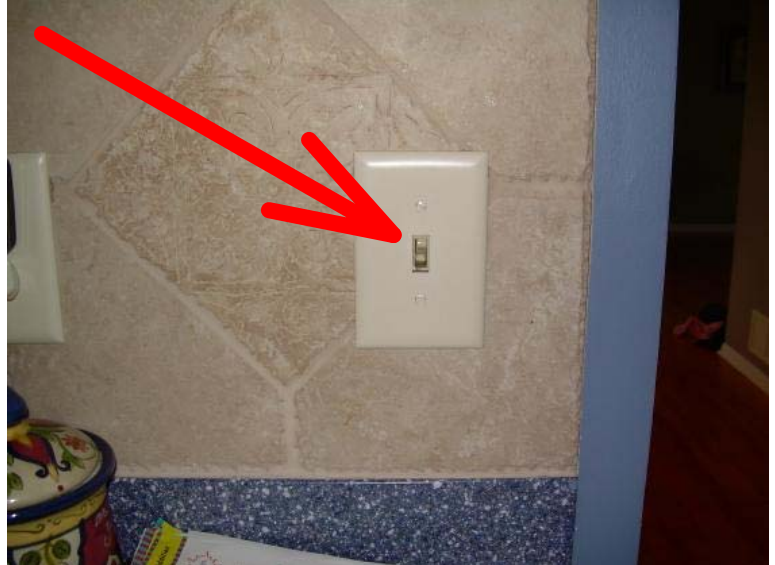
The wall switch to the right of the stove will not operate the can lights when the lights are turned off at the dimmer switch. Recommend evaluation and repairs be made by a qualified electrician.

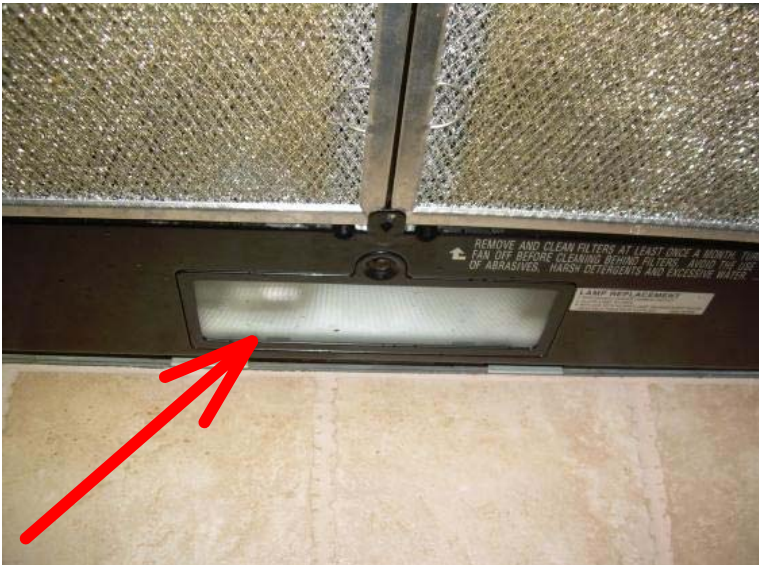
The light for the microwave that is for the stove cooking area doesn't work. Recommend replacement of the stove top light bulb.

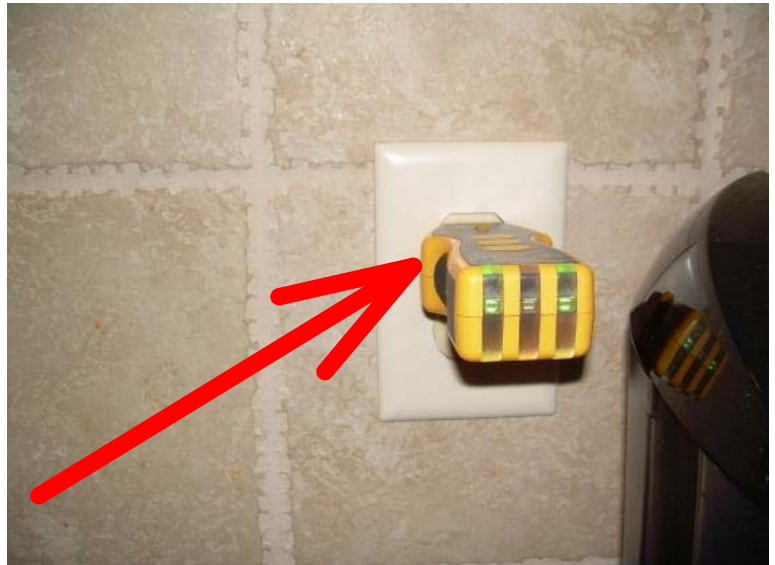
The kitchen wall outlets are not GFCI protected Recommend adding GFCI outlets to the kitchen for safety near water.

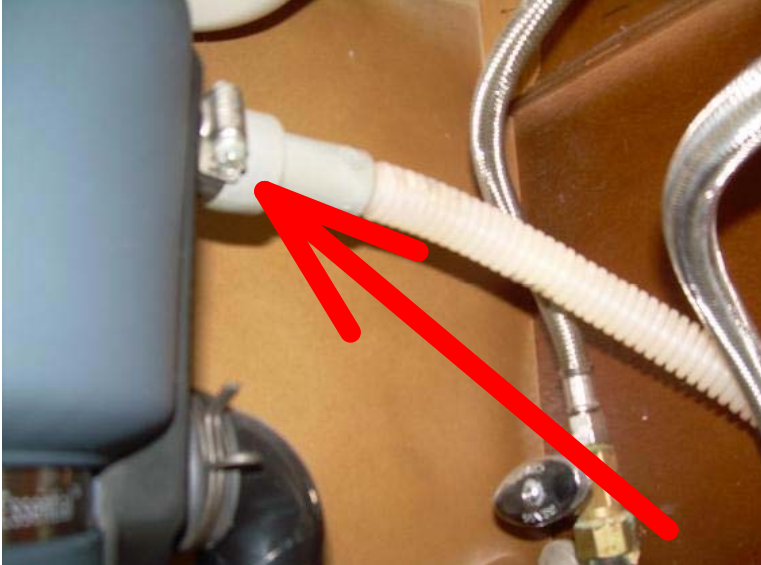
The dishwasher drain is improperly connected to the garbage disposal. This is an area for cross contaminating the water. Recommend having a qualified plumber install the dishwasher drain to the other side of the kitchen sink.

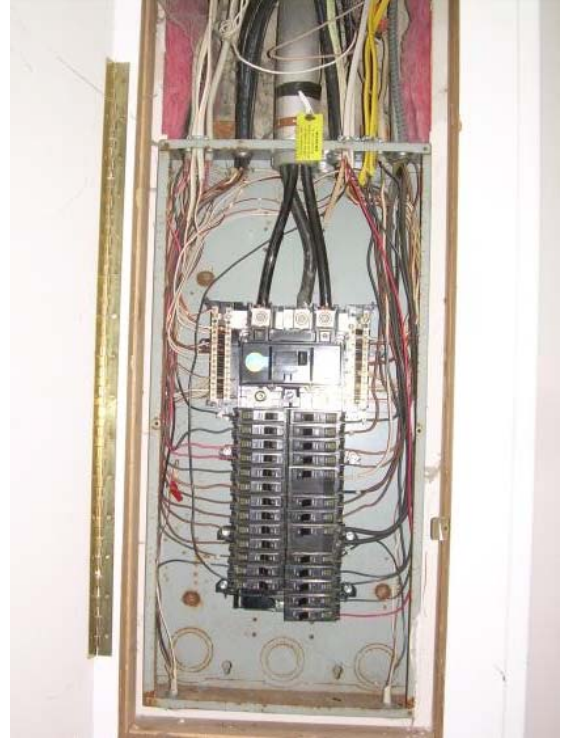
200 amp main electric panel with copper wiring and circuit breaker protection. The panel was in good condition at the time of the inspection.

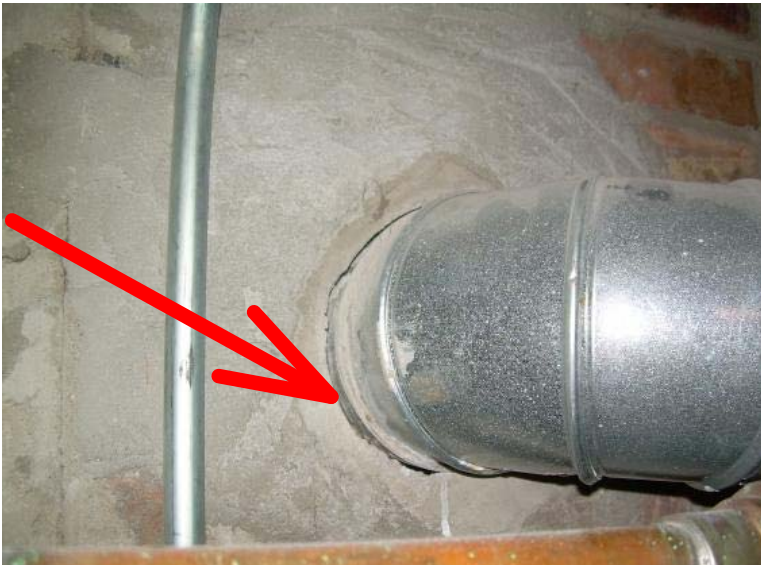
Where the furnace flue piping enters the masonry chimney there is a large gap between the piping and the brick. Recommend sealing with appropriate sealer by a qualified heating contractor.

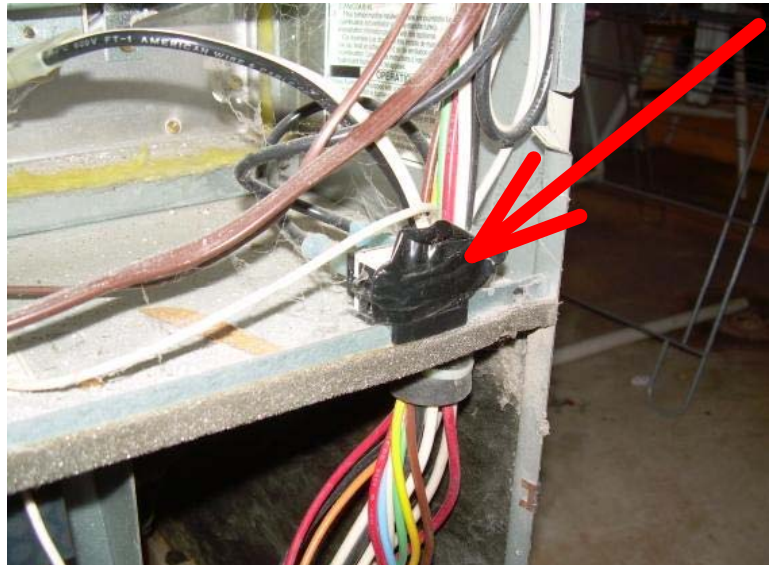
The blower door cut off switch has been taped over and bypassed. Recommend having a qualified heating contractor repair or replacement blower door cut out switch.

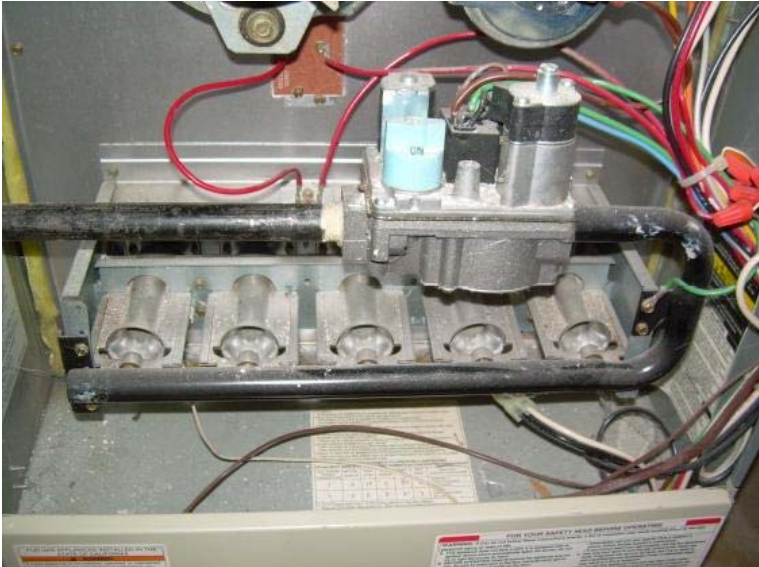
Cleaning recommended. It is recommended that the furnace be cleaned and serviced by a qualified heating contractor annually to help maintain proper operation of the furnace.

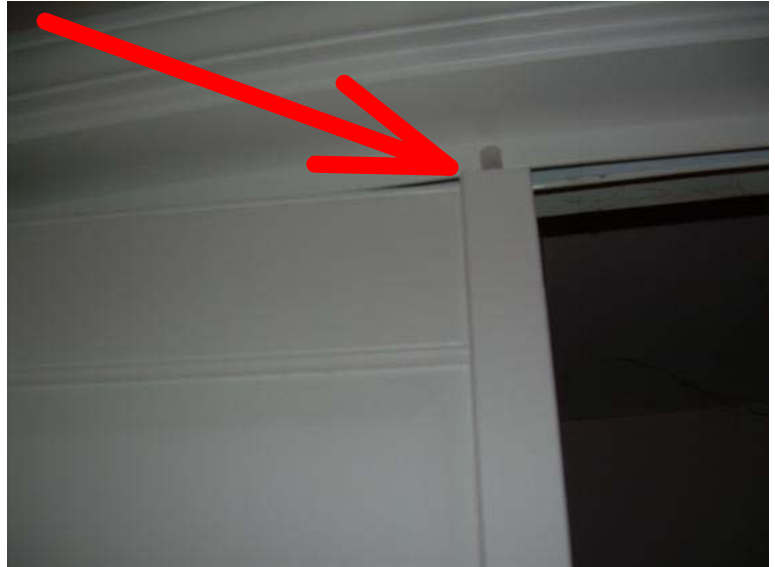
The basement closet doors on both sides have broken and missing door hardware and bind on the carpeting. Recommend repair or replacement of the doors.
